Entry type: FAQ, Entry ID: 12462284, Entry date: 01/20/2014

## MICROMASTER (MM4), SINAMICS G120 (CU2x0x): Guidelines for reliable USS communication from PLC to an inverter

This FAQ applies only to the SINAMICS G120/G120D Control Units without "-2" in the product name and MICROMASTER 4 inverters.

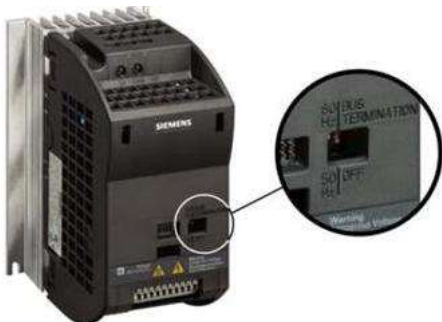
This is achieved by setting the Bus Termination DIP switches on the front of the inverter to the 'Bus Termination' position (refer to Fig. 2). It is important that both DIP switches (2 and 3) are set to the 'Bus Termination' position (not in the OFF position). A small screwdriver will be required to change the position of the DIP switches.

Fig. 2 – DIP switches for bus termination on G110

If a SINAMICS G110 or a SINAMICS G120 with a Control Unit CU240S or CU240E is the first or last node on the bus, the build in the drive / control unit bus termination resistor must be used for bus termination.

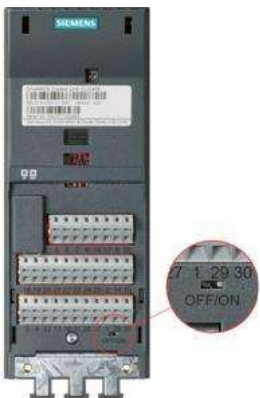
On the CU240E the USS termination can be activated via the Bus Termination Switch on the front side of the housing of the Control Unit (refer to Fig. 4). The switch is set in the position "ON".

Fig. 4 – DIP switch for bus termination on CU240E

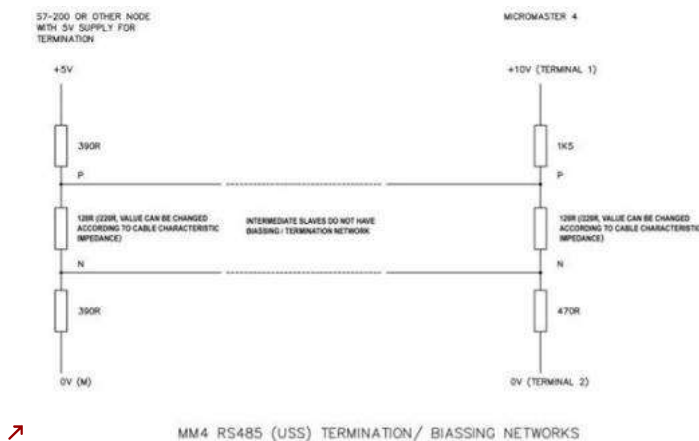
If the first or last node on the bus has a 5V supply for biasing (e.g. S7-200 PLC with 226 CPU) then the standard biasing/termination resistor values should be used. These are 390R pull up and pull down (+5V to P and N to 0V), and 220R from P to N (refer to Fig. 5).

Fig. 5 – Biasing/termination of the bus on sides of the S7-200 and MICROMASTER 4

Since the USS is referenced to 0V (M on the S7-200, refer to Fig. 5), optimum performance is usually obtained when 0V lines (MM terminal 2, S7-200 "M" terminal, refer to Fig. 5) on all nodes are connected together. This could be done as an additional core in the USS cable, or a separate wire close to it. Measures should be taken to prevent noise being coupled to this. However, if the 0V is connected to earth at one or more points, this could provide a path for additional noise. This is particularly likely at the PLC if the 24V supply (L+, M) is used for supplying other devices and/or the I/O.

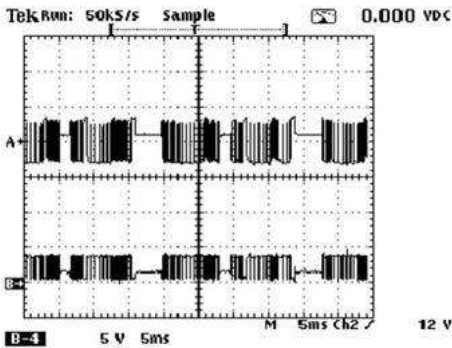
(3) Look at the bus voltage on an oscilloscope. Check that the idle state bias is 0.5 - 1V; an example of a good voltage is shown below. The differential signal (P-N, top trace in the example) should be substantially free from noise. Some noise on the common mode signal (P or N to earth, bottom trace) is acceptable, but noise spikes should not exceed 5V as this may cause USS driver damage. Check all of the above points.

Fig. 6 – Bus voltage, 19.2 kbaud

Bus voltage, 19.2 kbaud:  
 Ref A = P to N  
 Ref B = N to earth
